## Robinson Helicopter Company Accident Report

AIRCRAFT MODEL:	<u>R44 Clipper I</u>
SERIAL NUMBER:	<u>1295</u>
REGISTRATION:	<u>N7530R</u>
ACCIDENT DATE:	<u>30 January 2018</u>
ACCIDENT LOCATION:	<u>Newport Beach, California</u>
NTSB IDENTIFICATION:	<u>WPR18FA077</u>

REPORT WRITTEN BY: Ken Martin

DATE: 17 June 2019

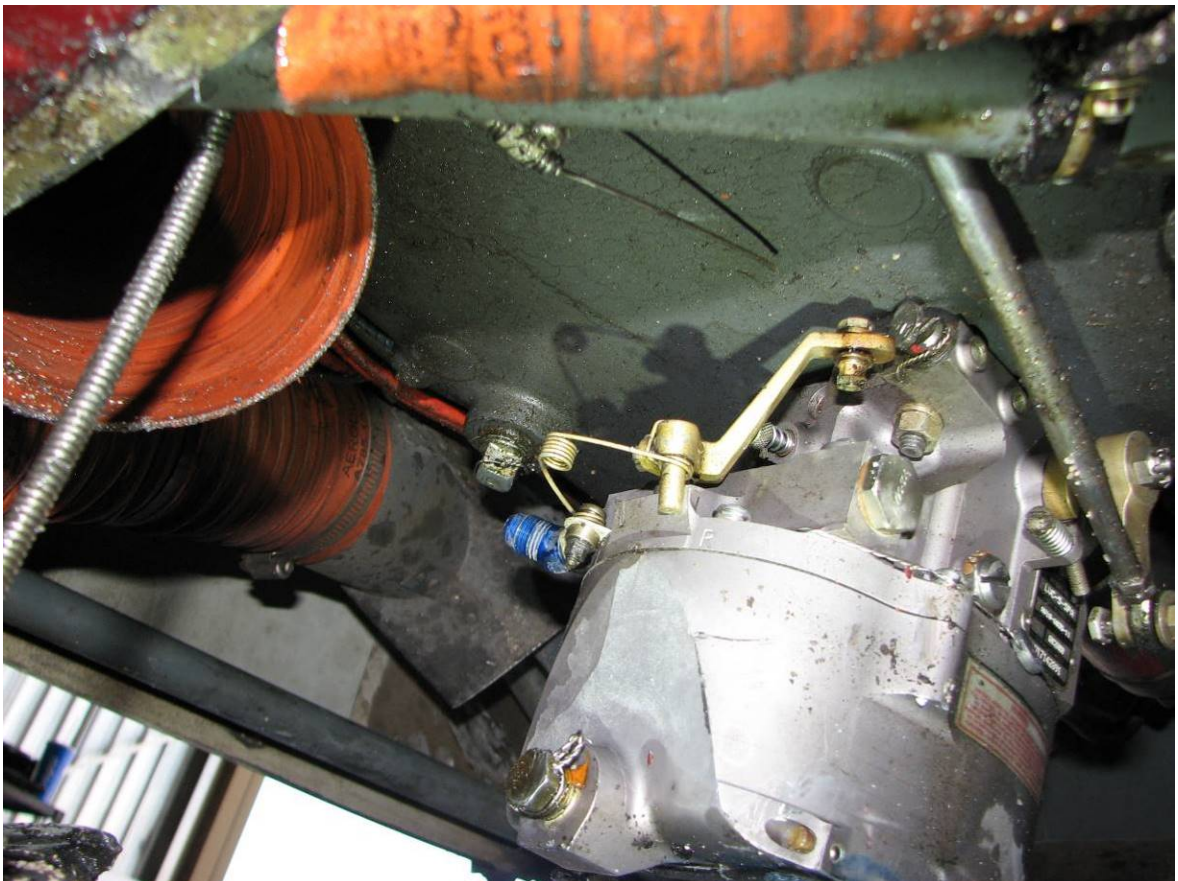
The fuel mixture control knob was in the full rich position. The fuel mixture control knob guard was recovered near the cabin. The fuel mixture control arm on the carburetor was in a full rich position and moved freely yet the control wire was detached from the fitting. The hardware on the fitting was secure. The return spring was in place. The fuel mixture control wire sheath was secure in the mounting clamps on the mount. The mount was separated from the airbox.

The fuel mixture control arm at the carburetor, showing detached cable

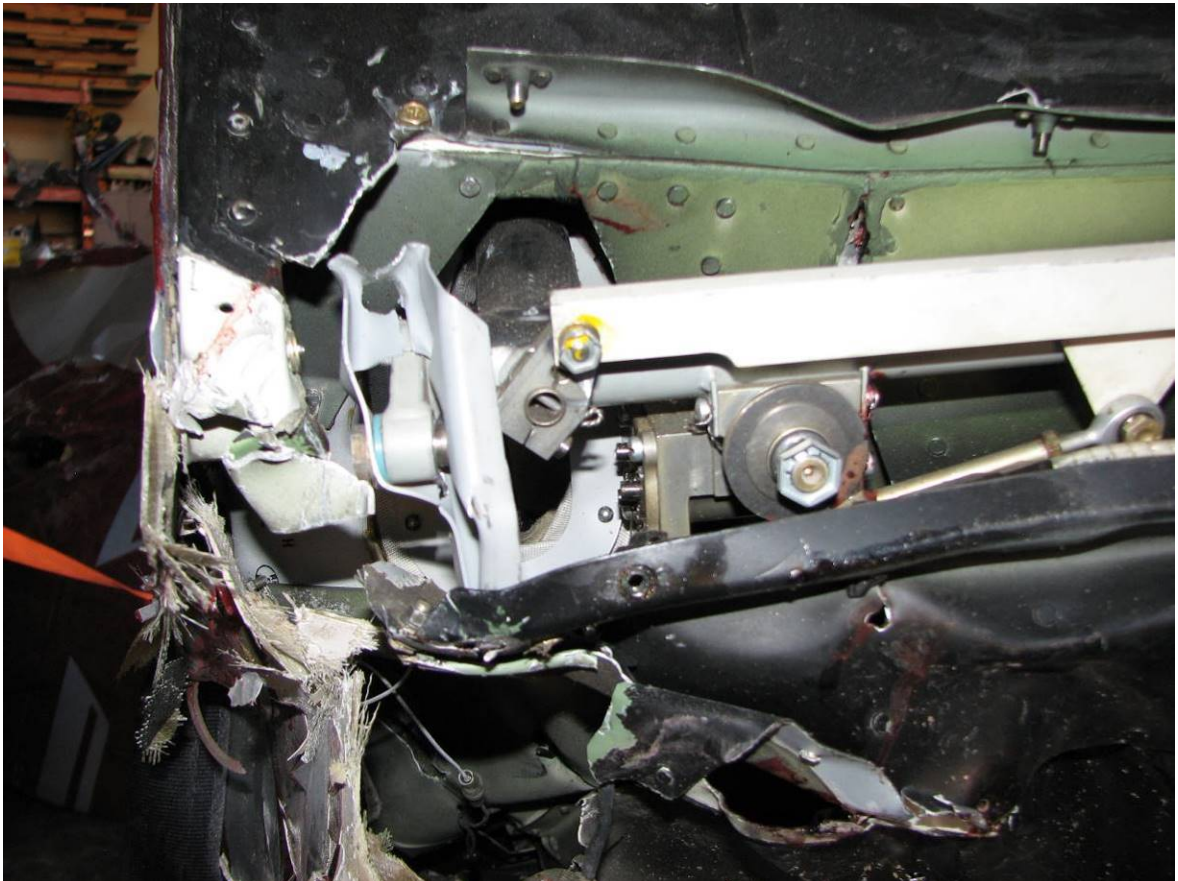
The throttle connecting rod on the collective was in an approximately  $\frac{1}{4}$  open position. The throttle arm on the carburetor was in a fully open position yet the control push pull tube was bent upward. There were several disconnects in the throttle linkage. The surfaces of all of the disconnects were angular and jagged.

The throttle connecting rod at the back of the collective

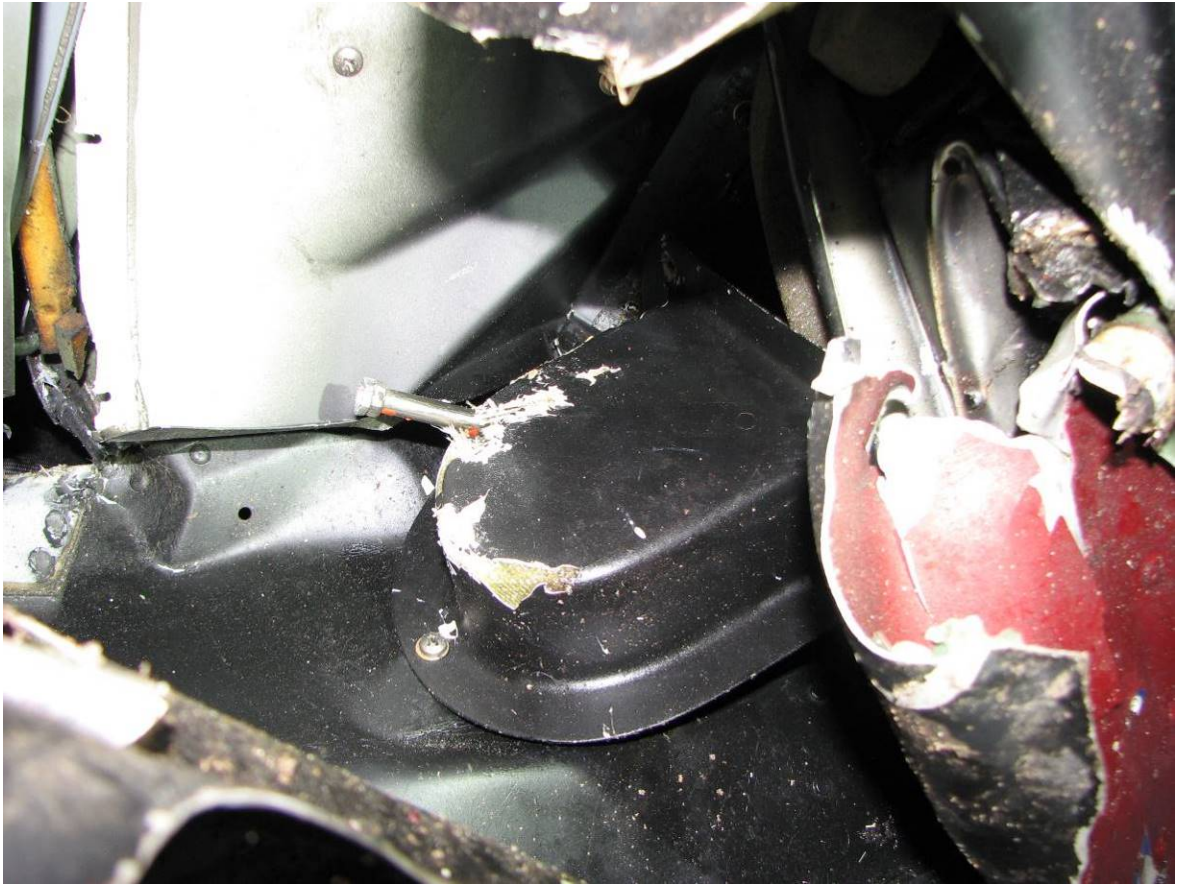
The forward end of the C336-1 throttle push pull tube

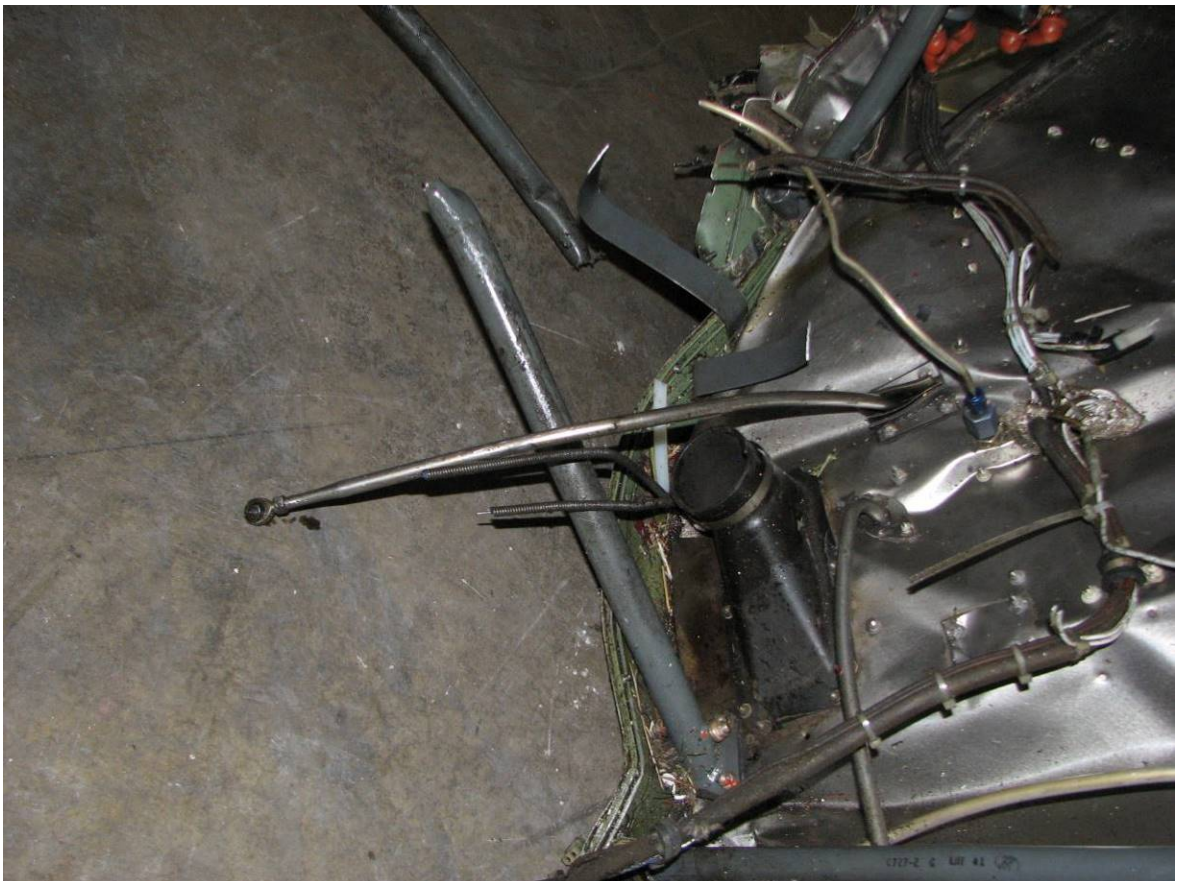
The aft end of the C336-1 throttle push pull tube

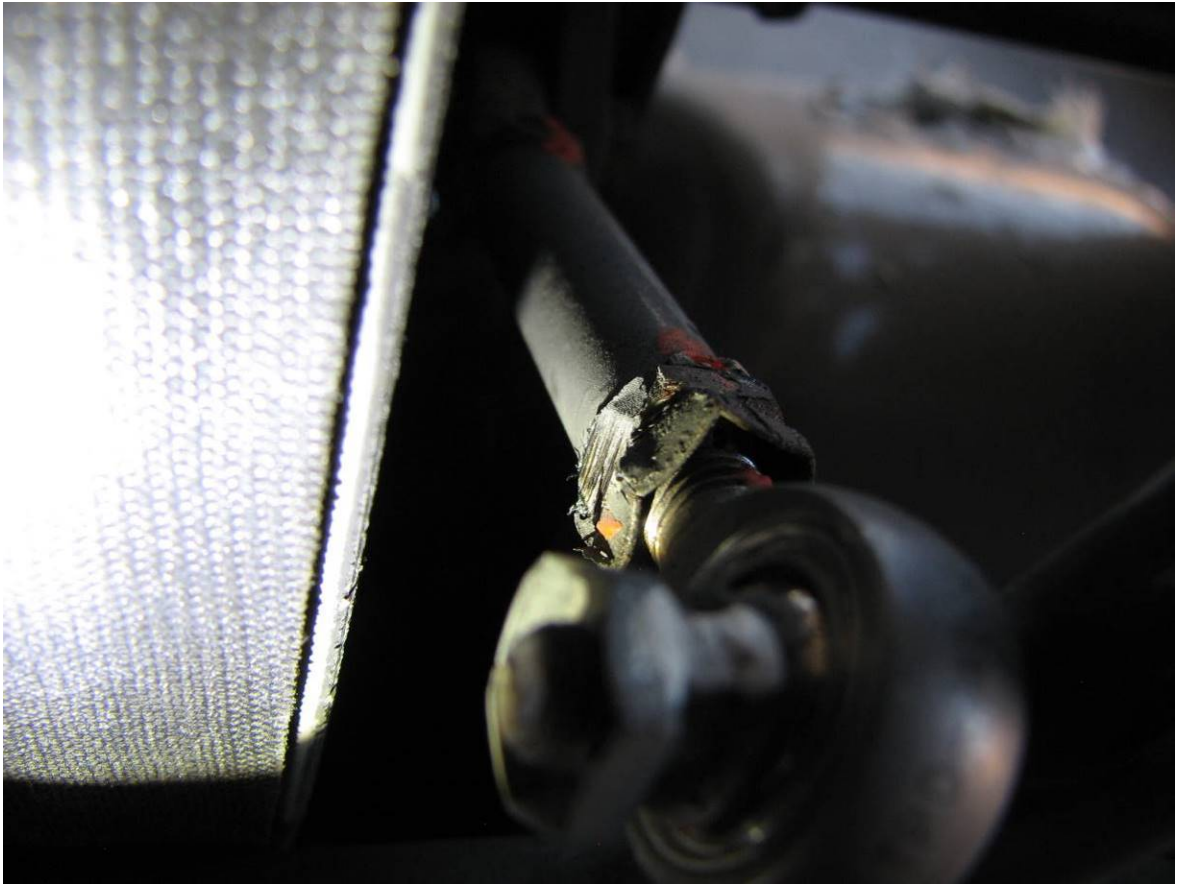
Scoring on the clutch centering link

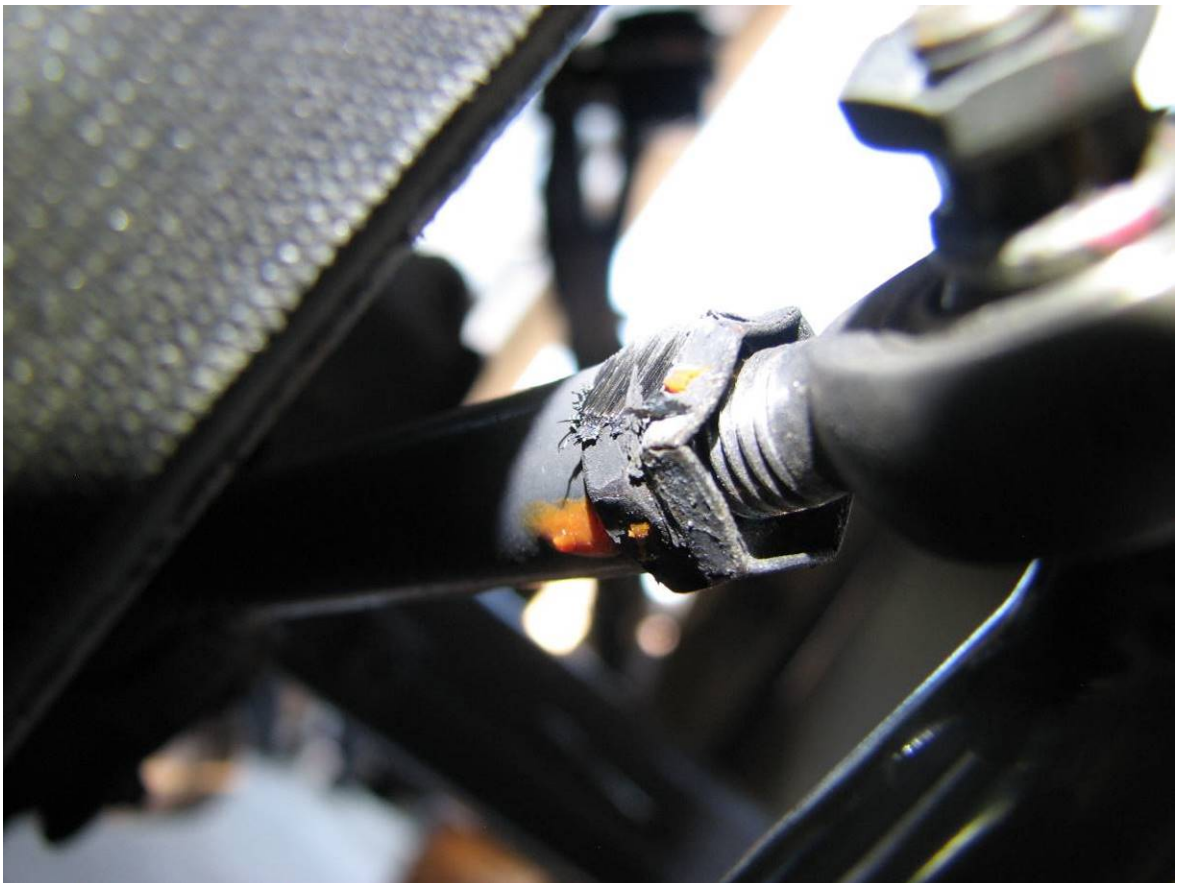
Scoring on the clutch centering link

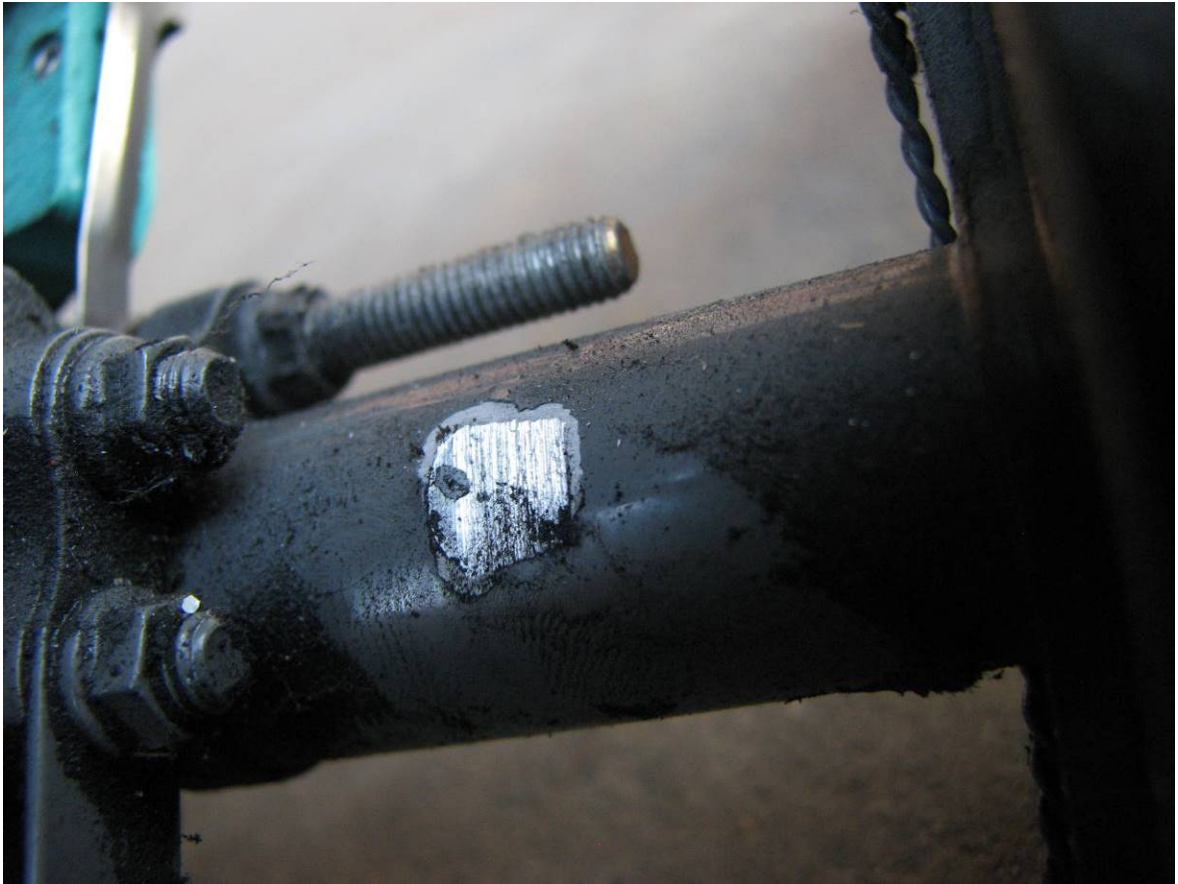
Scoring on the belt tension actuator

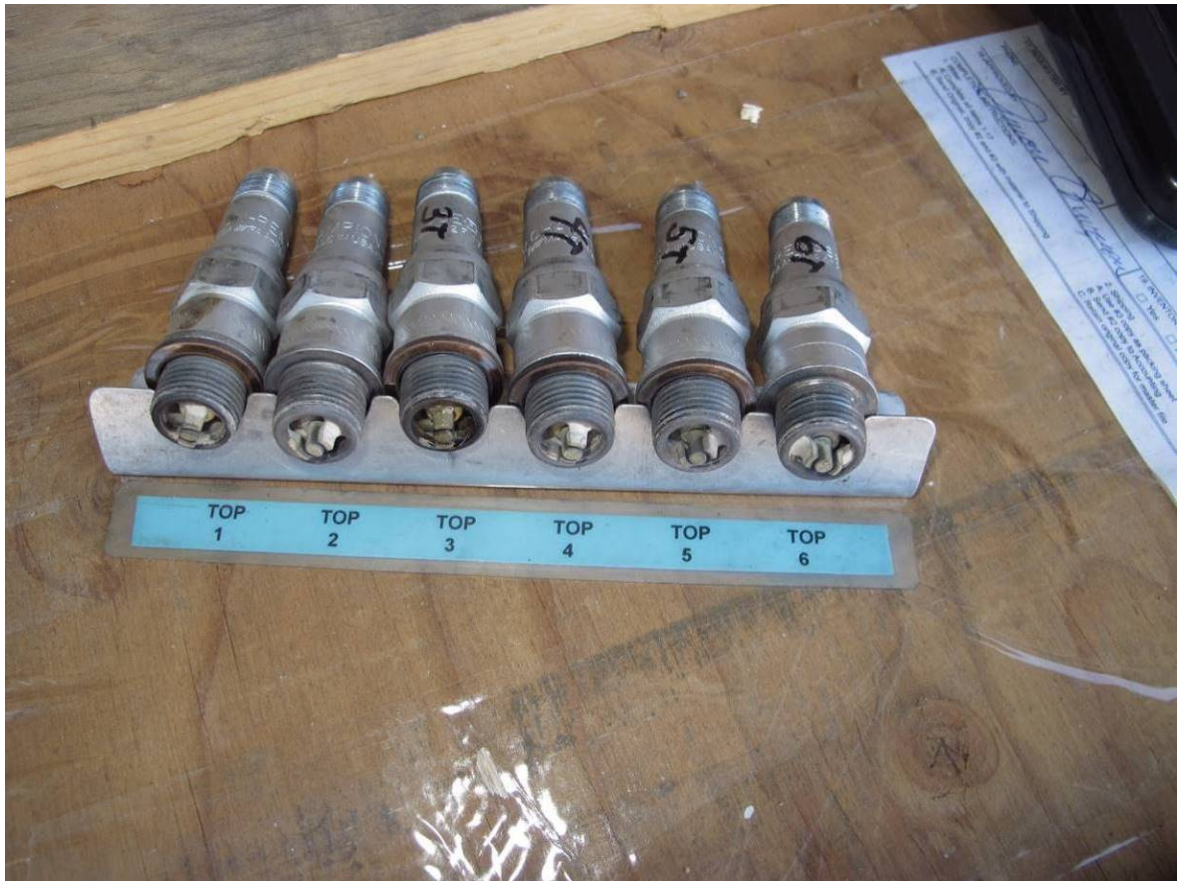
Upper spark plugs, after removal

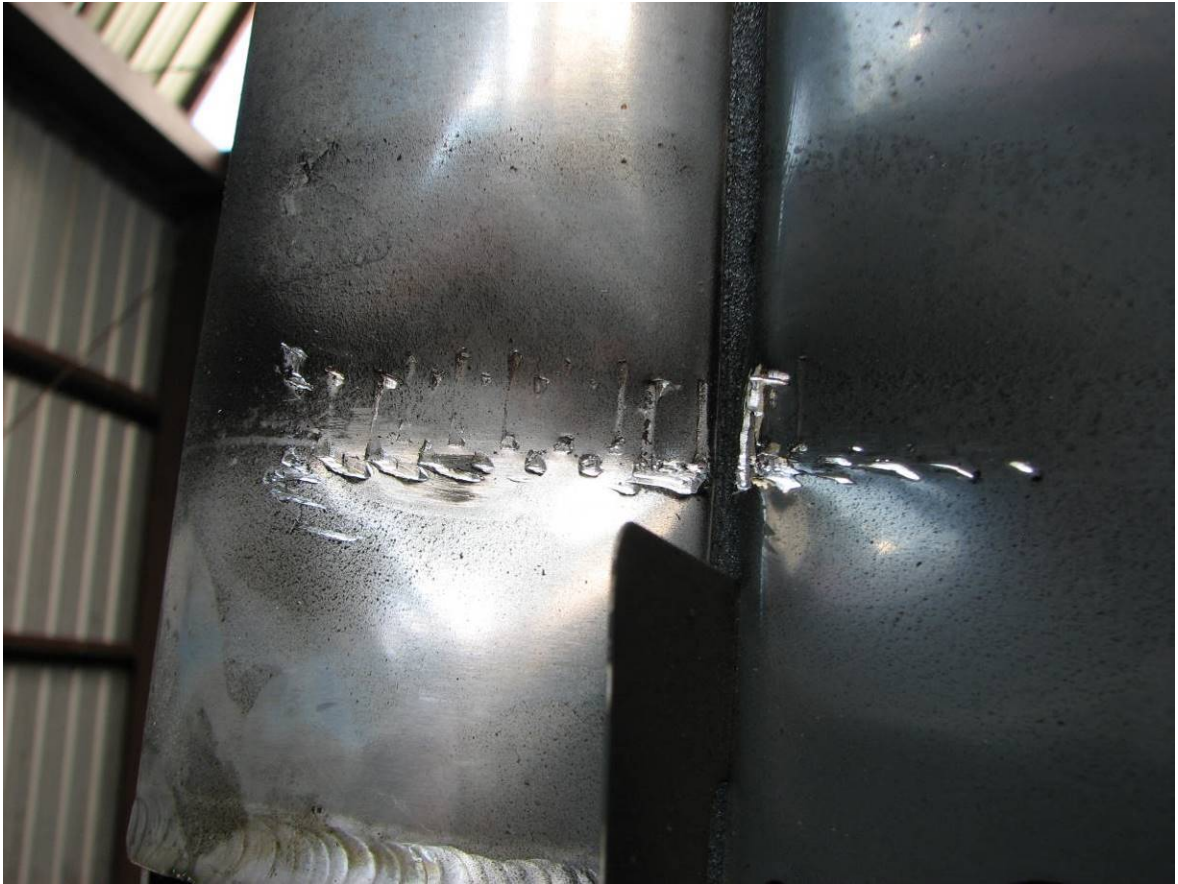
Row of dents in oil cooler and cooling panel

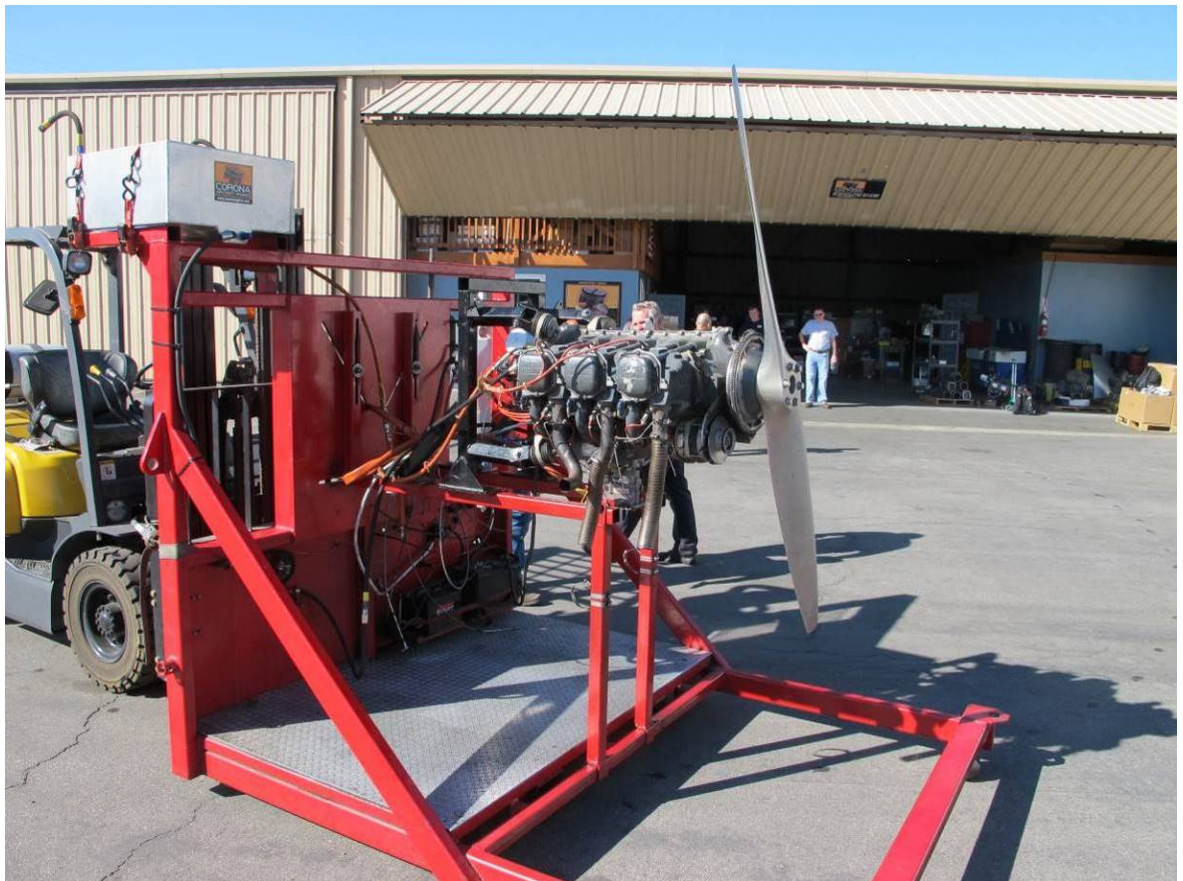
The engine was placed on a test stand and functionally tested. After replacing the damaged ignition wires, the engine was run at full power with no anomalies. See Lycoming's accident report for details on performance.

Engine on test stand

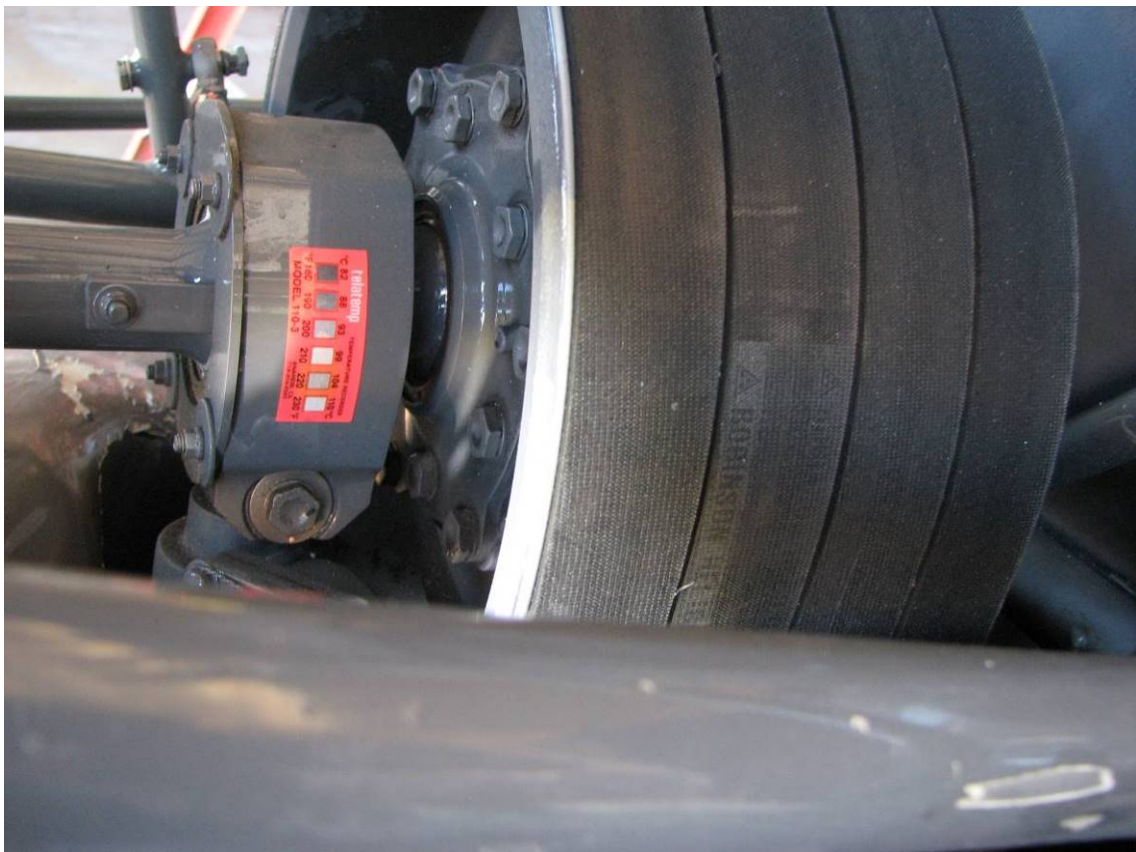
The V-belts at the upper sheave, from the right side of the aircraft

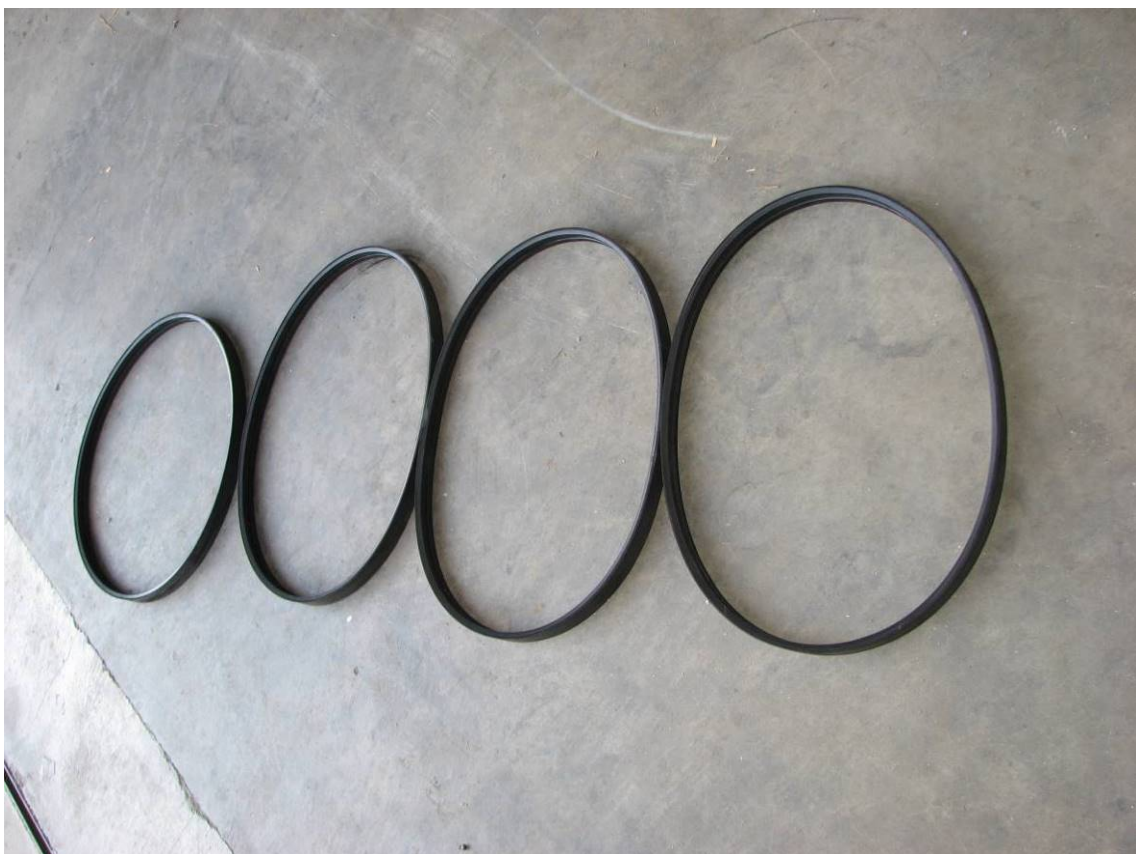
The V-belts, after removal from the aircraft

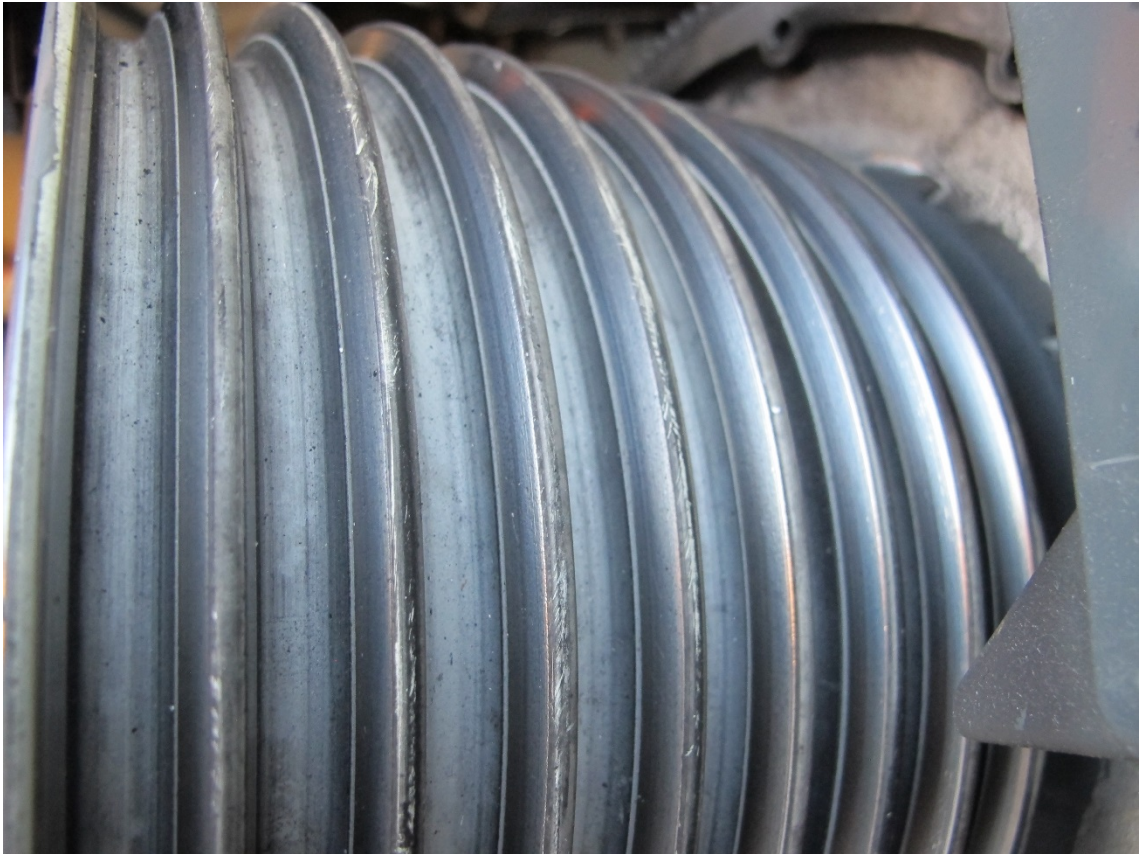
The grooves on the lower and upper sheaves showed normal wear.

The lower sheave grooves

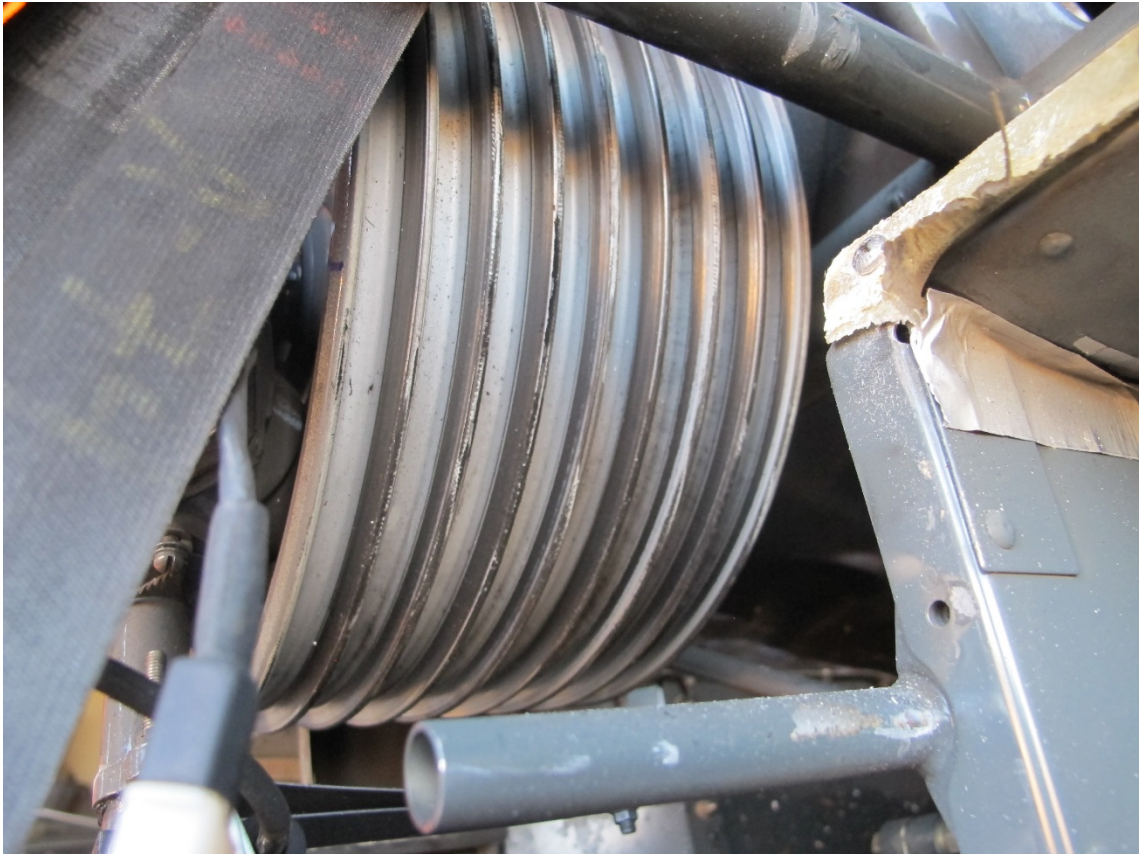
The upper sheave grooves

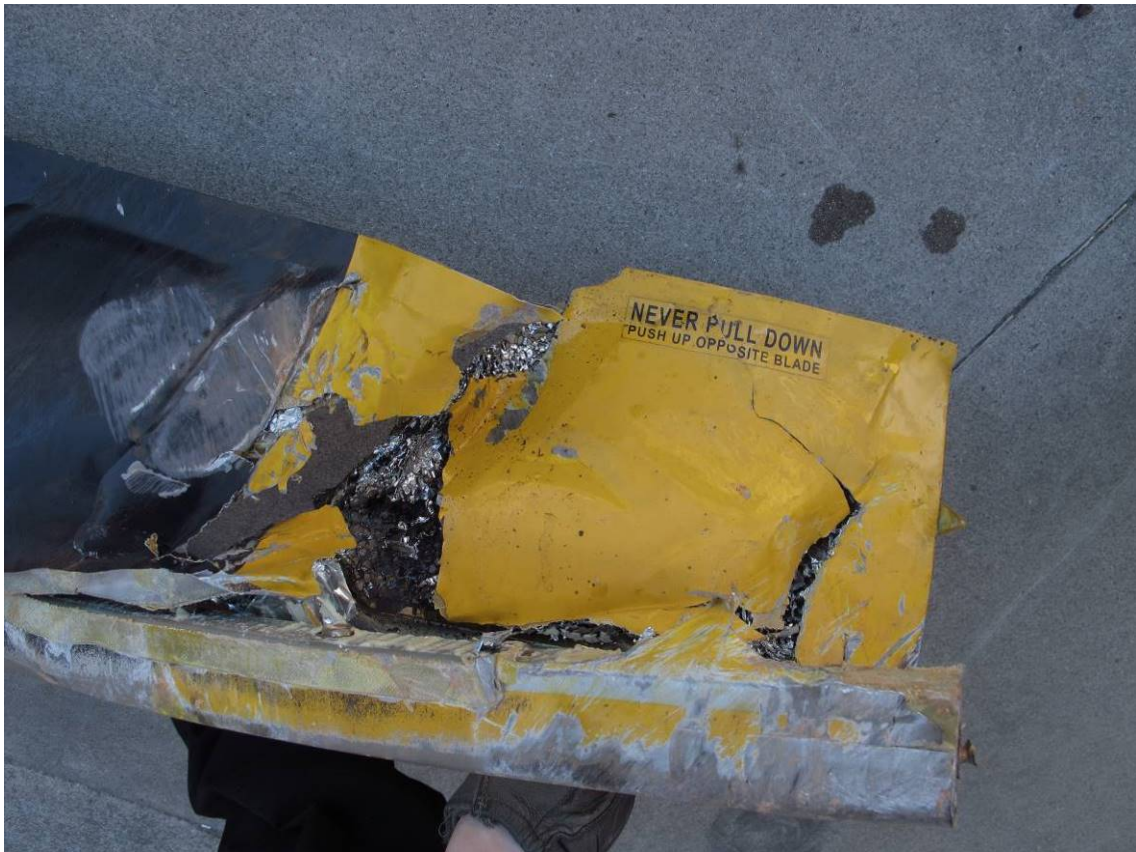
Main rotor blade SN 7862, lower surface, at tip (detached afterbody is being held in place by hand)

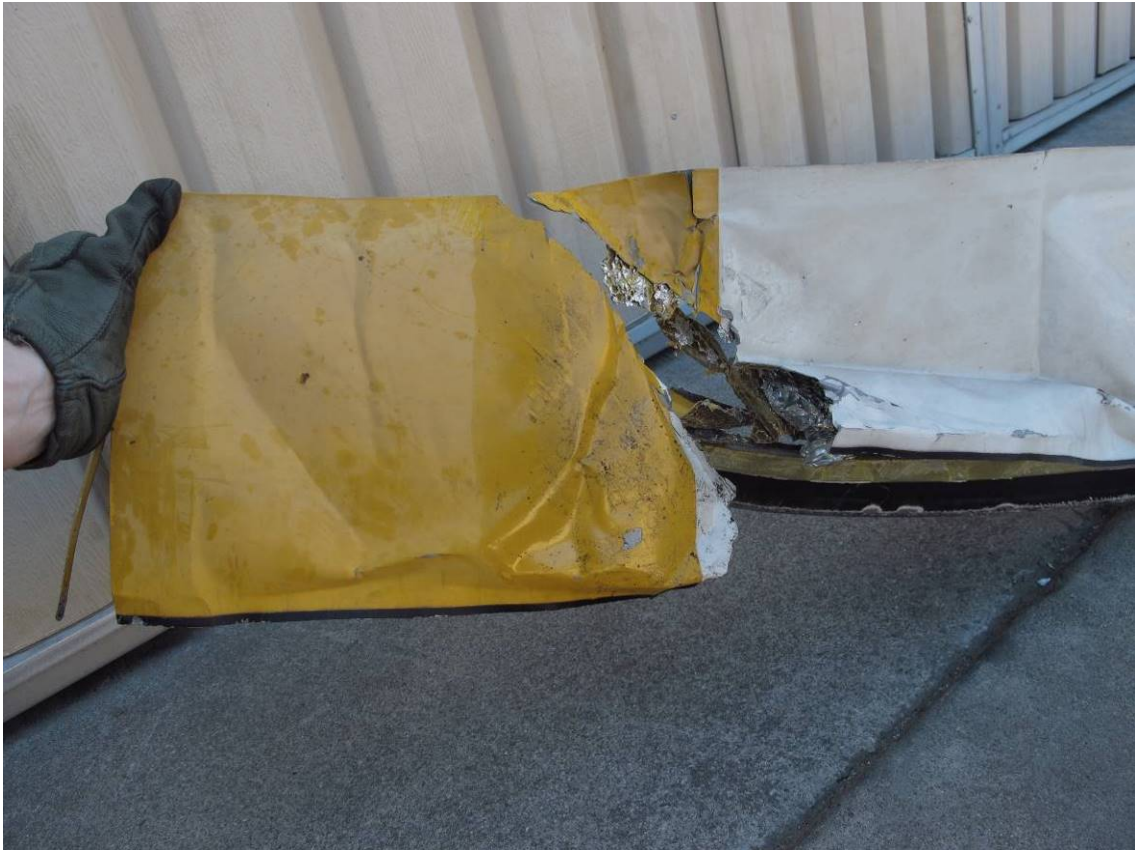
Main rotor blade SN 7862, detached portion at tip, lower surface

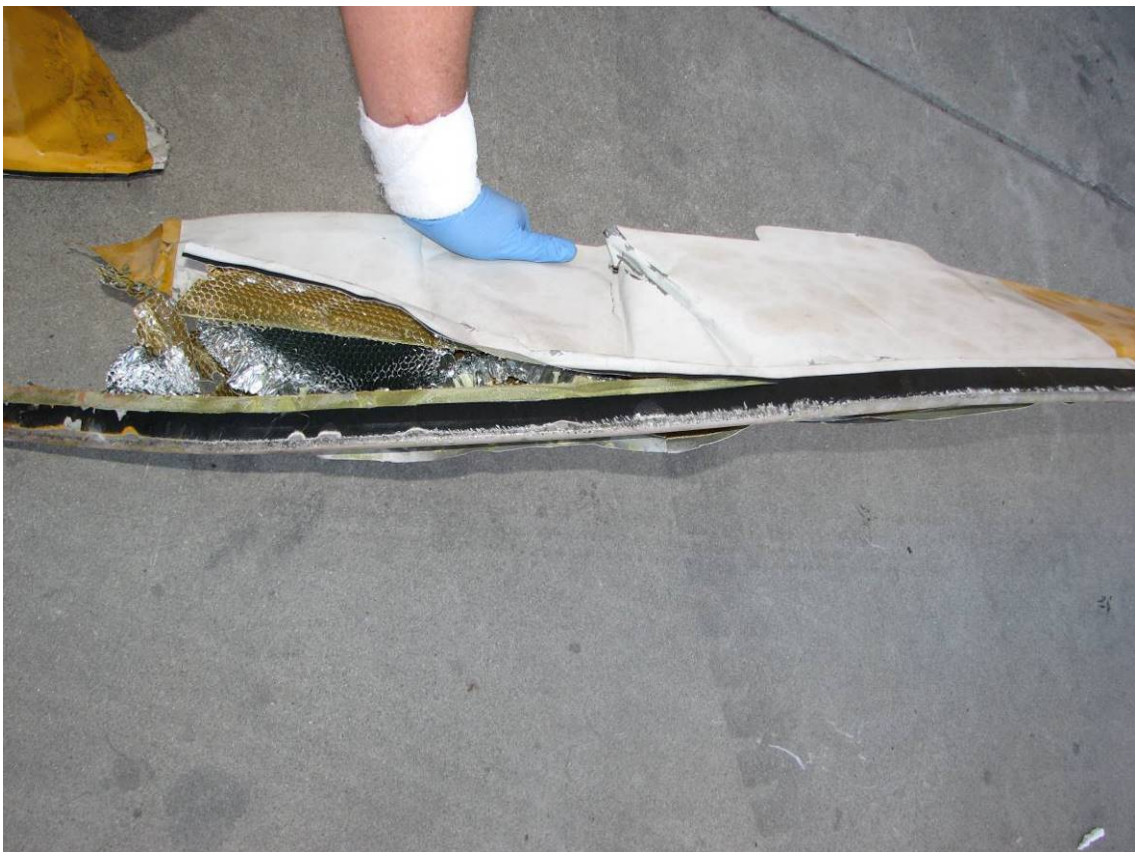
Main rotor blade SN 7862, detached portion at tip, upper surface

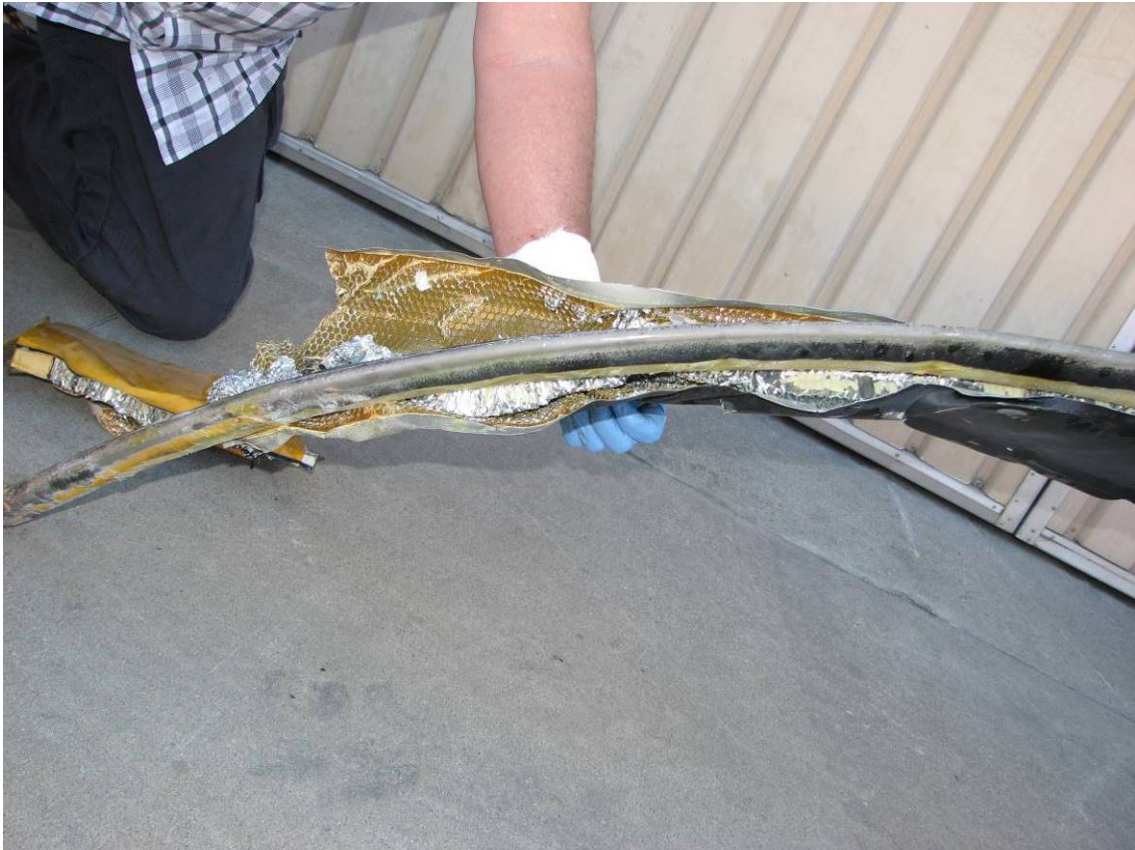
Main rotor blade SN 7862, upper surface, near tip

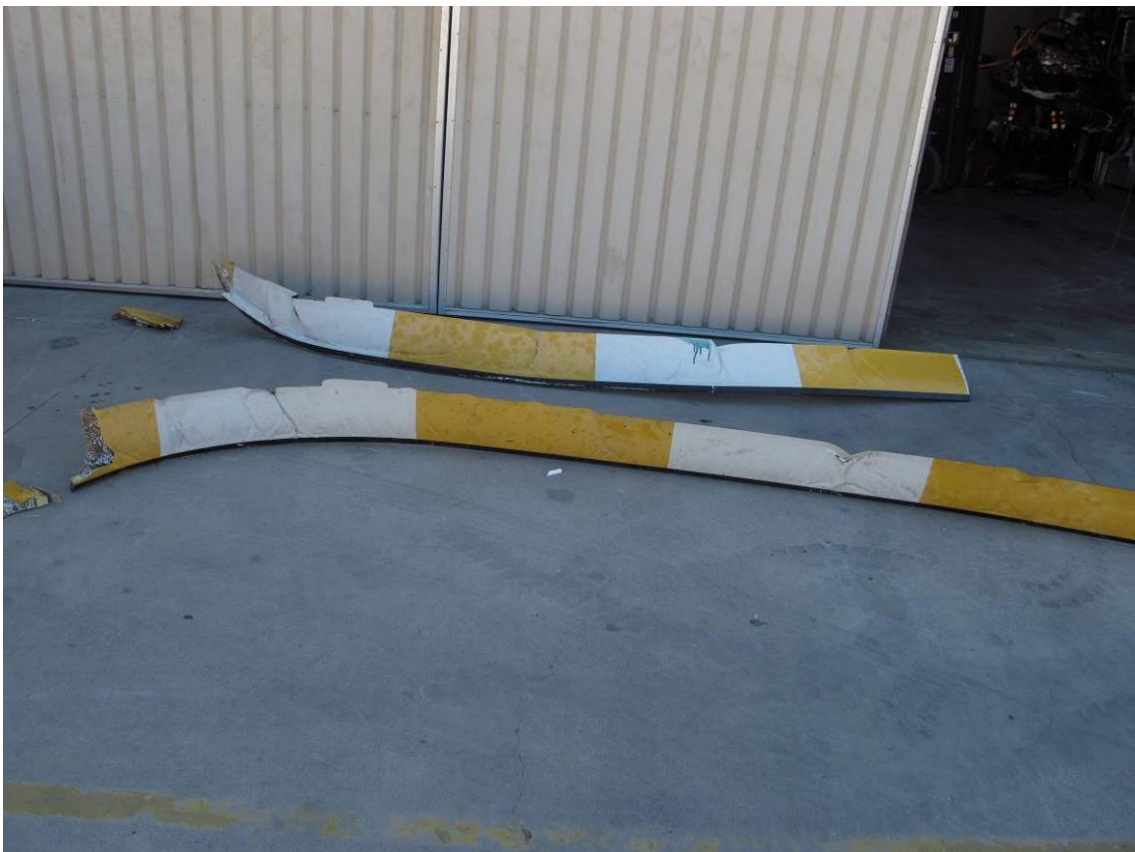
Main rotor blade SN 7862, leading edge, near tip

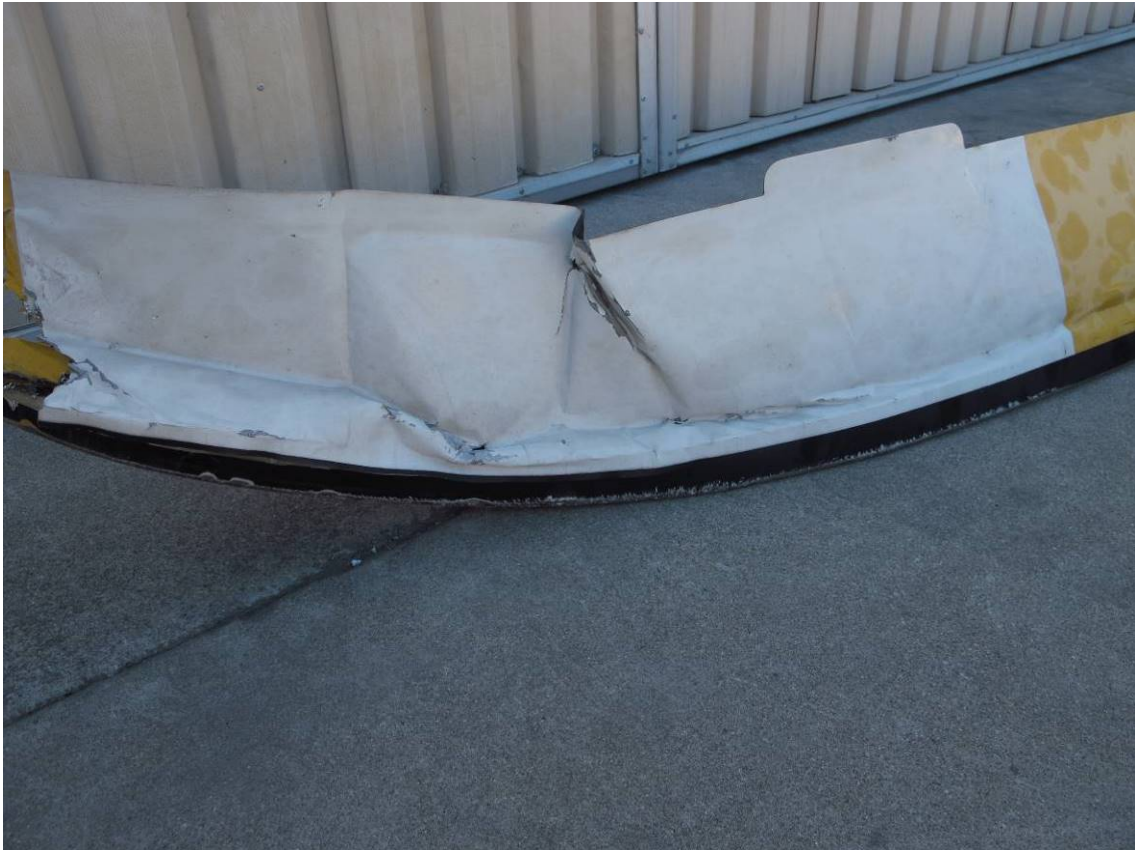
Main rotor blade SN 7862, upper surface (at rear in photo)

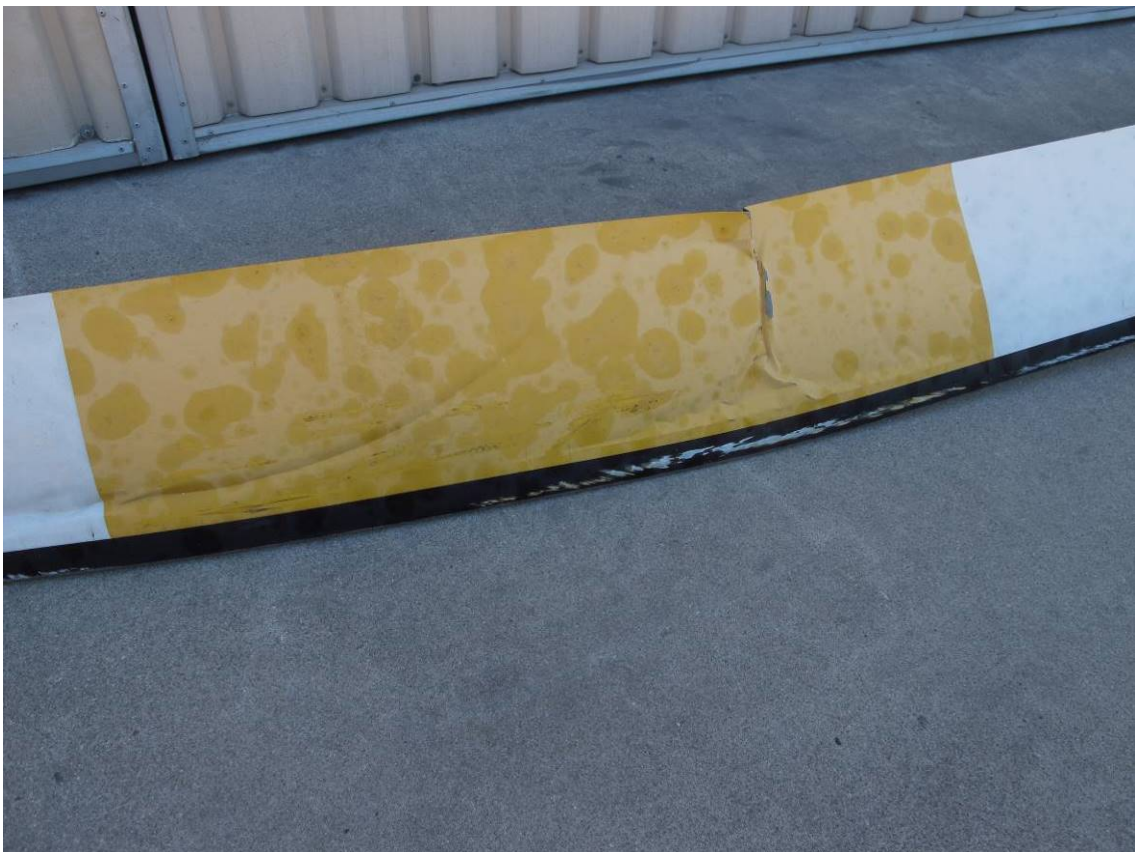
Main rotor blade SN 7862, upper surface, center portion

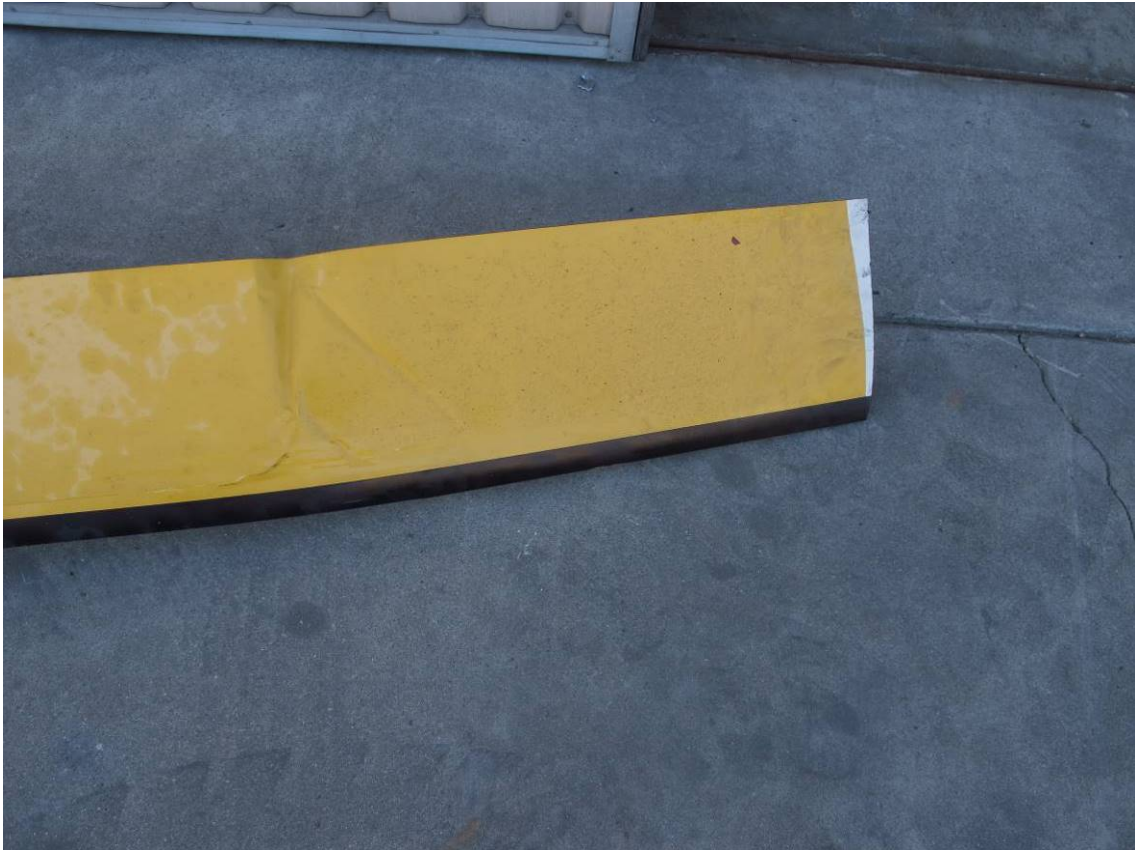
Main rotor blade SN 7862, upper surface, center portion
